SPECIAL FOCUS – December 2019

Shrinking water reservoir levels in Southern Africa

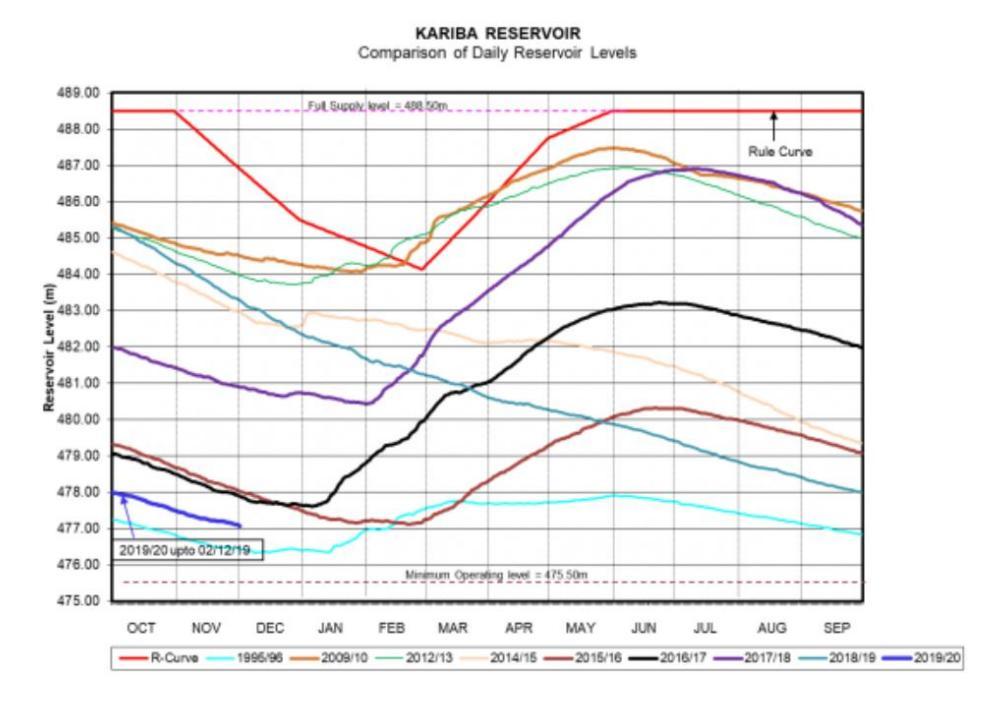
Figure 2. Time series data for Kariba Lake's reservoir levels (source: Zambezi River Authority).

In Figures 2 and 3, we can see that in November 2018, Kariba Lake was already below full capacity while Vaal Dam still had a storage capacity classified as "moderately high". Figures 4, 6 and 8 show the extent of surface water for the above-mentioned reservoirs, derived from high-resolution satellite images for the month of November 2019 and 2018. Additionally, Figures 5, 7 and 9 present the extent of permanent water for comparison purposes (JRC Yearly Water Classification History). In all three cases, the November 2019 water extent is clearly below that of November 2018 as well as below the median values for permanent water between 2001-2018 according to the JRC Surface Water Explorer. Albeit clearly visible with satellite imagery, the decrease of the water surface is not as striking as the reported level decreases, due to the fact that we are mapping the change in water surface extent, while we do not monitor directly the water content (storage), since the relationship between the two depends on the shape and depth of the basin. Monitoring of storage consists in associating water surface elevation and area after evaluating them independently (Frappart et al.2006). With the applied method and by using high-resolution satellite data we map quickly and accurately only the water surface extent. Monitoring will remain relevant in the coming weeks to see to what level the ongoing seasonal rainfall will contribute to reservoir replenishment.

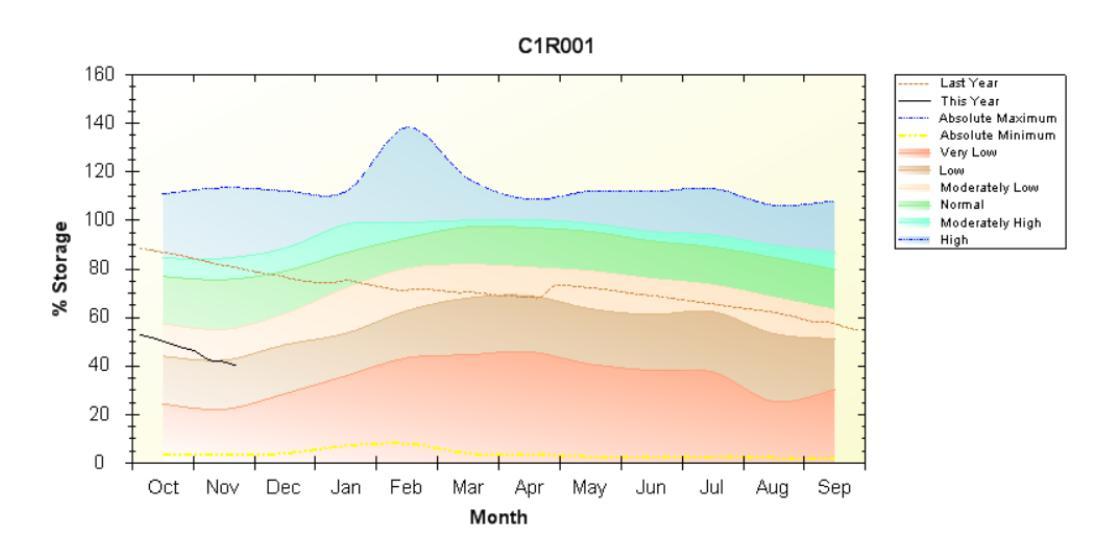
Figure 3. Data for Vaal Dam storage progress (source: Department of Water and Sanitation of South Africa).

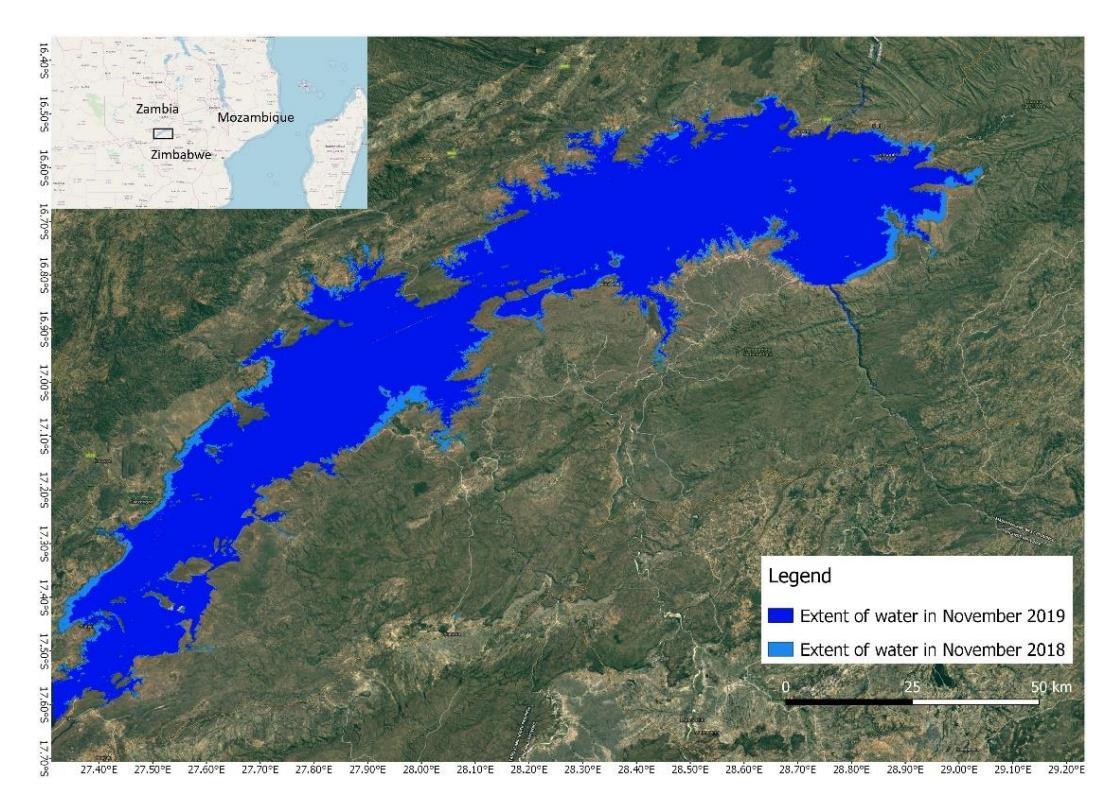
Figure 4. Extent of water in Lake Kariba in November 2019 and November 2018 as estimated from Sentinel 2 images (Background layer: Google Satellite).

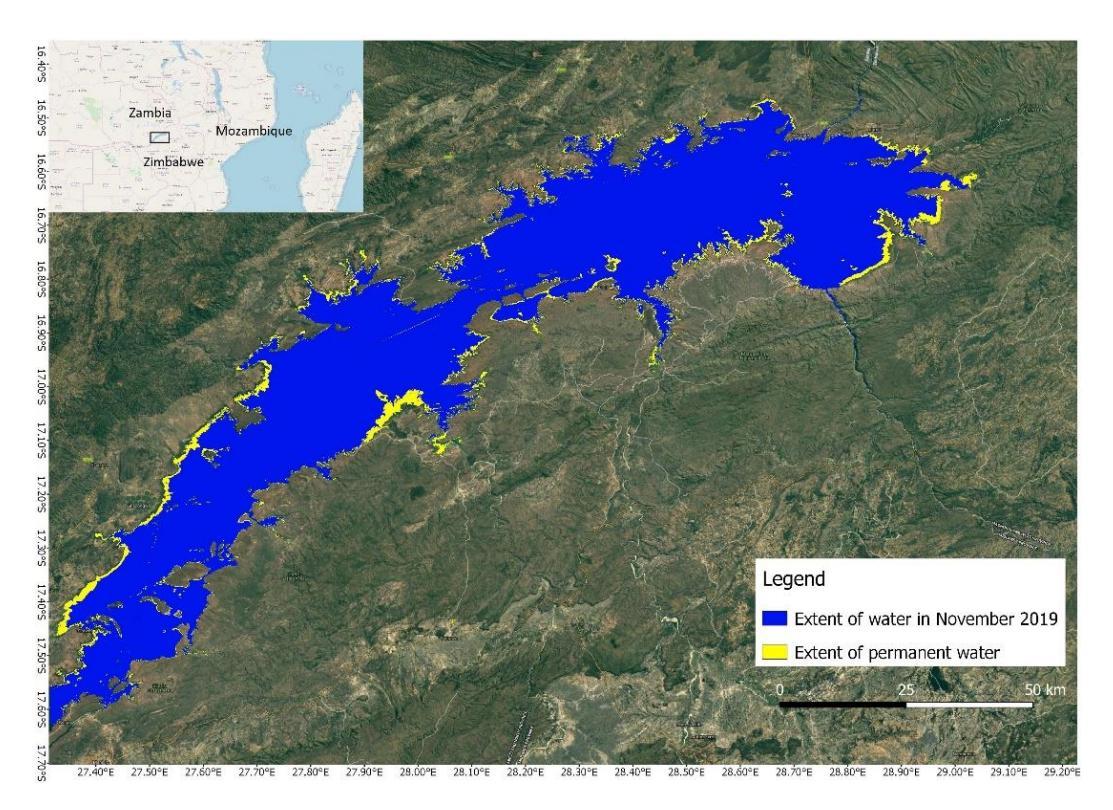
Figure 5. Extent of water in Lake Kariba in November 2019, estimated from Sentinel 2 images and compared with the JRC Yearly Water Classification History layer (median values for permanent water layer between 2001-2018 - Source: EC JRC/Google, Background layer: Google Satellite).

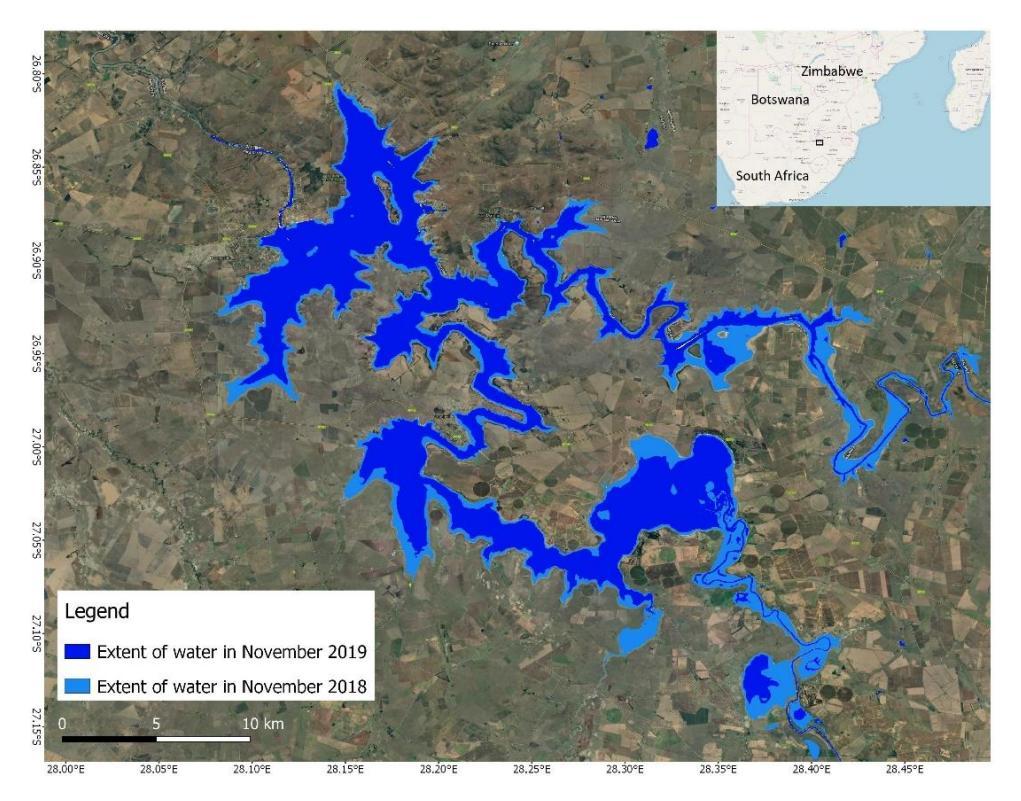
Figure 6. Extent of water in Vaal Dam in November 2019 and November 2018 as estimated from Sentinel 2 images (Background layer: Google Satellite).

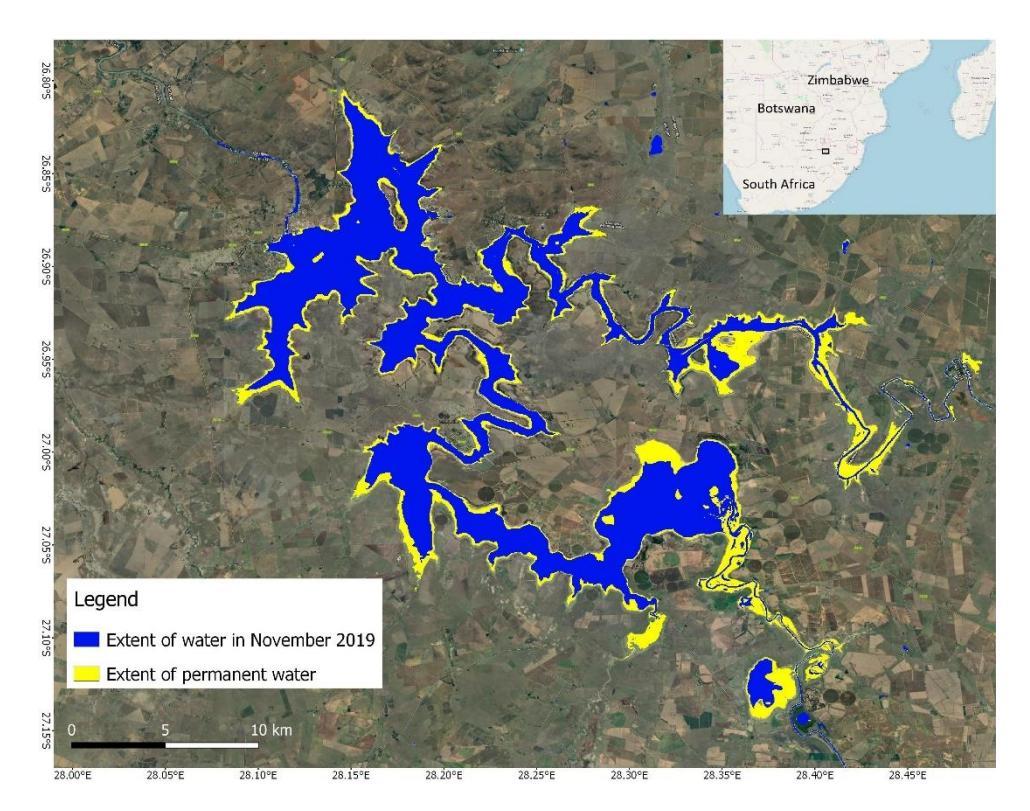
Figure 7. Extent of water in Vaal Dam in November 2019, estimated from Sentinel 2 images and compared with the JRC Yearly Water Classification History layer (median values for permanent water layer between 2001-2018 - Source: EC JRC/Google, Background layer: Google Satellite).

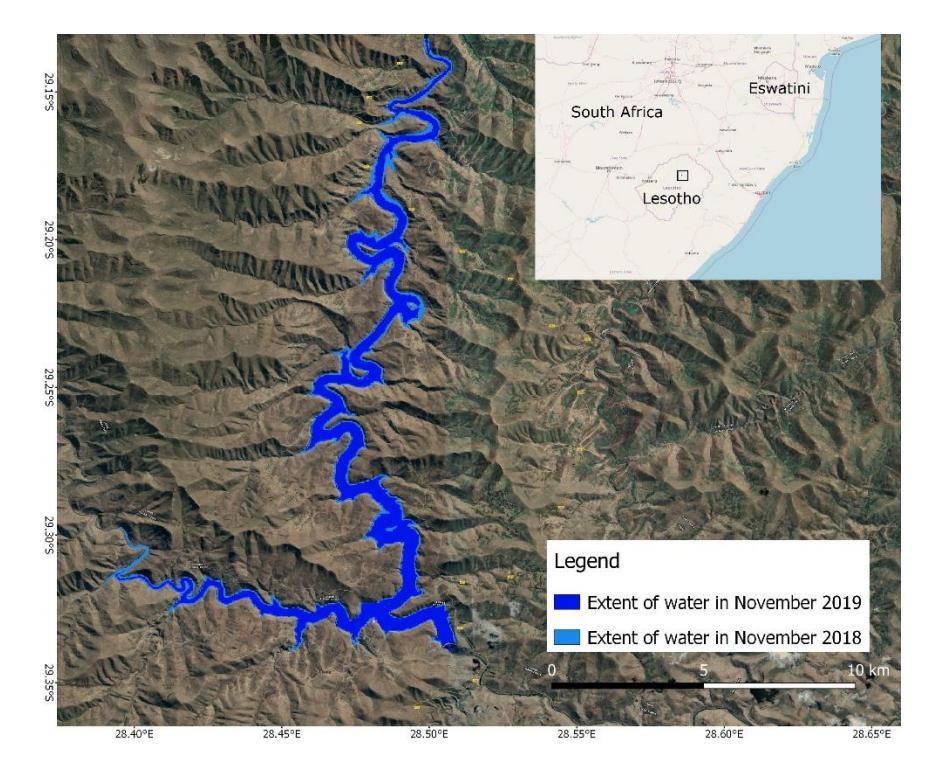
Figure 8. Extent of water in Katse Dam in November 2019 and November 2018 as estimated from Sentinel 2 images (Background layer: Google Satellite).

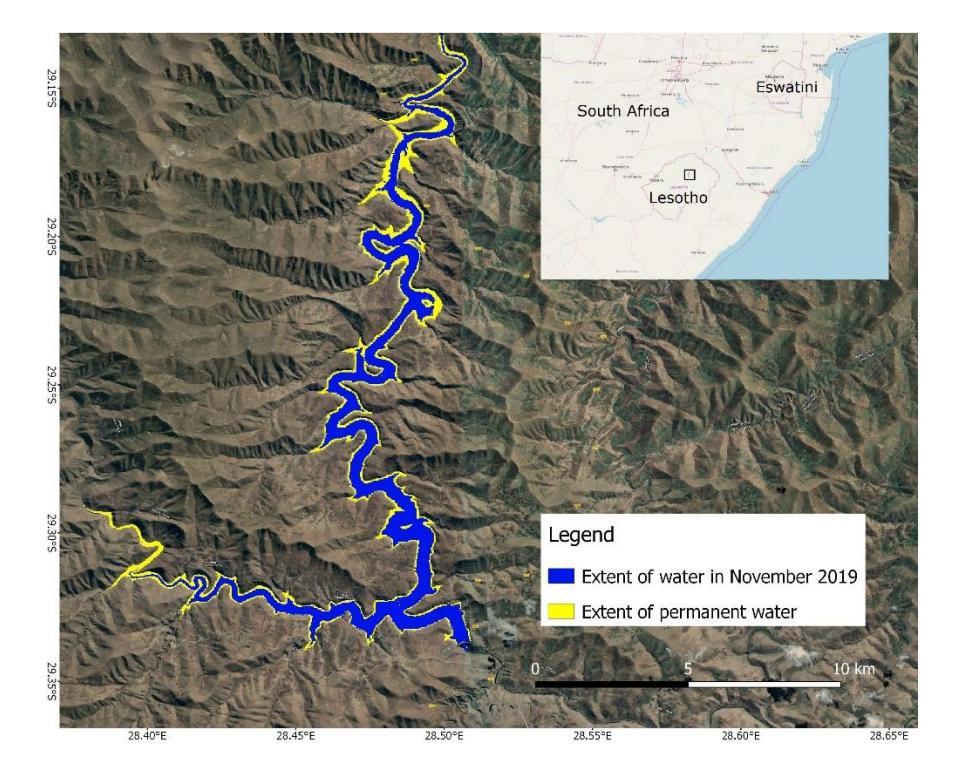
Figure 9. Extent of water in Katse Dam in November 2019, estimated from Sentinel 2 images and compared with the JRC Yearly Water Classification History layer (median values for permanent water layer between 2001-2018 - Source: EC JRC/Google, Background layer: Google Satellite).
